## Refurbishment and recladding of 1970s classroom and laboratory block William Parker Community Secondary School in Daventry, UK

## Annex 36: Case Study Report

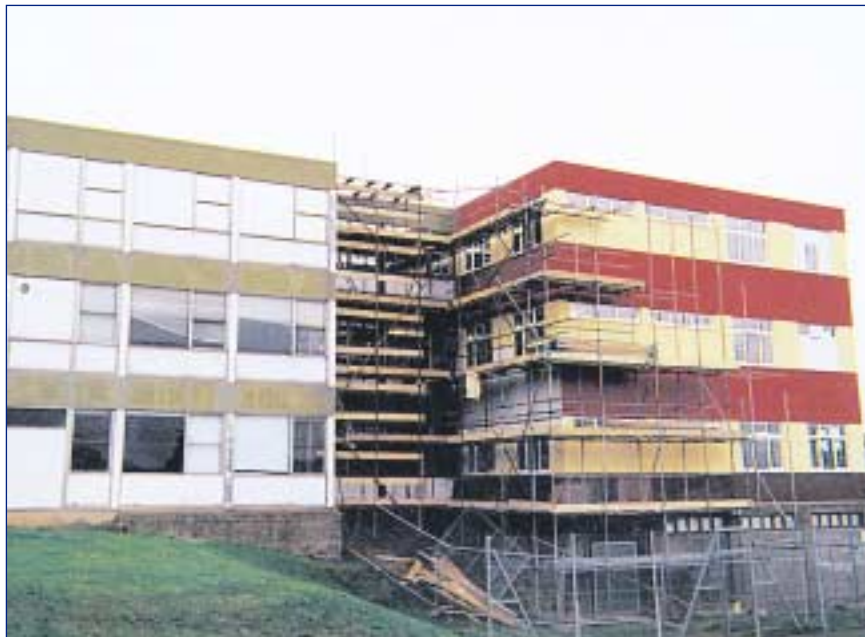
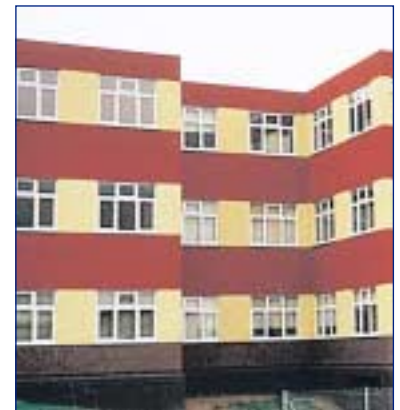
**Figure 1:** Left: Rear of block showing cladding half completed. Below: Rear of block after recladding

The existing curtain walling was retained to minimise disruption to the school and to avoid cost of supporting/modifying services. “Structherm” structural insulated cladding was fixed externally to the existing aluminium curtain walling and directly to the main steel stanchions. Ceilings were replaced and new high efficiency electric lighting was provided.
