## Exemplary Retrofitting of a School (EROS) in Stuttgart-Plieningen, Germany

## Annex 36: Case Study Report

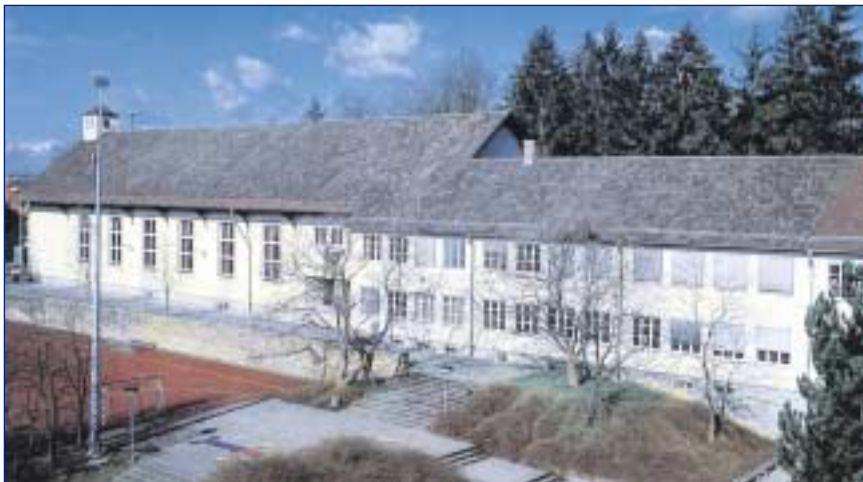
**Figure 1:** South view of the school building (building segments 1 and 2)

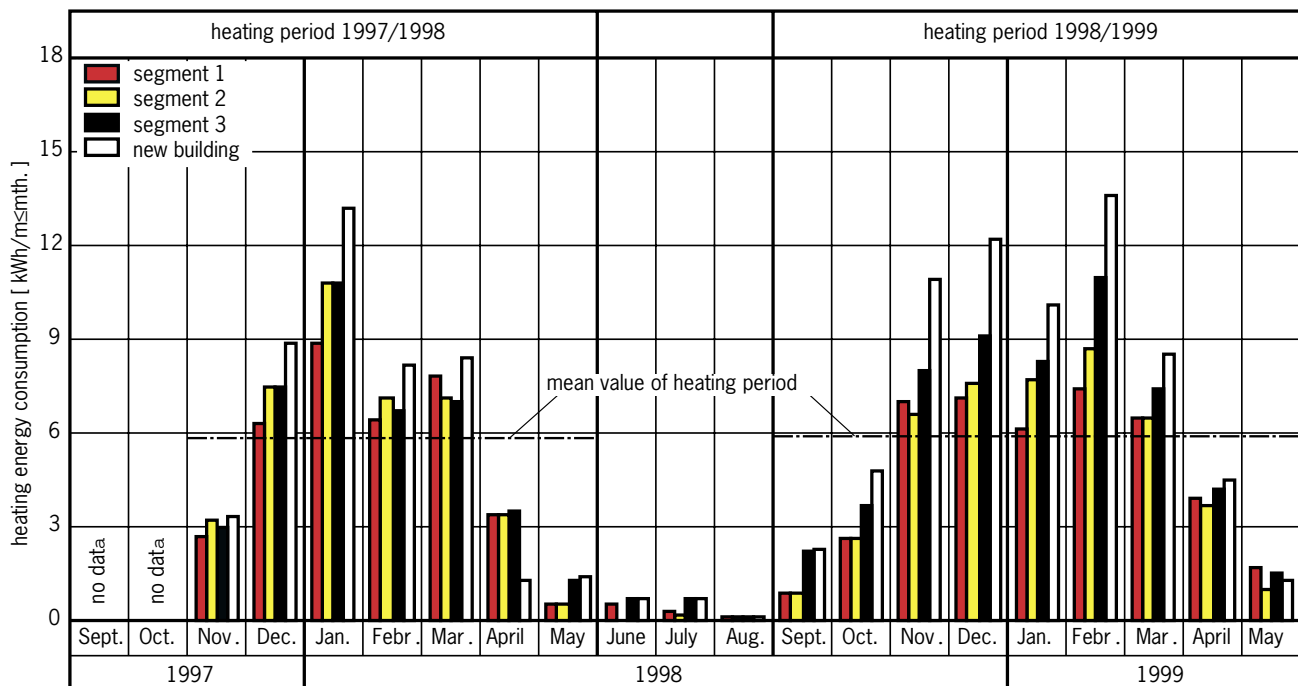
**Figure 3:** Monitored monthly heating energy consumption of all building segments during the heating periods 1997/1998 and 1998/1999.

The energy consumption in the early nineties averaged about  $210 \text{ kWh/m}^2\text{a}$ , the original value of 1977 being  $382 \text{ kWh/m}^2\text{a}$ . This was mainly the result of "good housekeeping", that is 'no-cost measures' enforced by the city of Stuttgart. After retrofitting the heating consumption was monitored as  $49 \text{ kWh/m}^2\text{a}$ . The efficiency of the new heating system with two boilers was monitored and shown to be 95%.

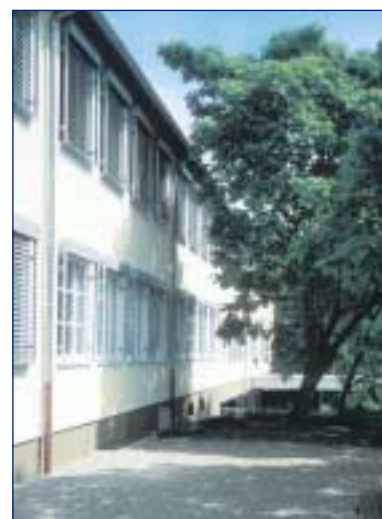
**Figure 4:** Building segment 1 after the retrofit.
