## Natural ventilation at Vridsløselille School, Albertslund, Denmark

### 2 Project summary

## Annex 36: Case Study Report

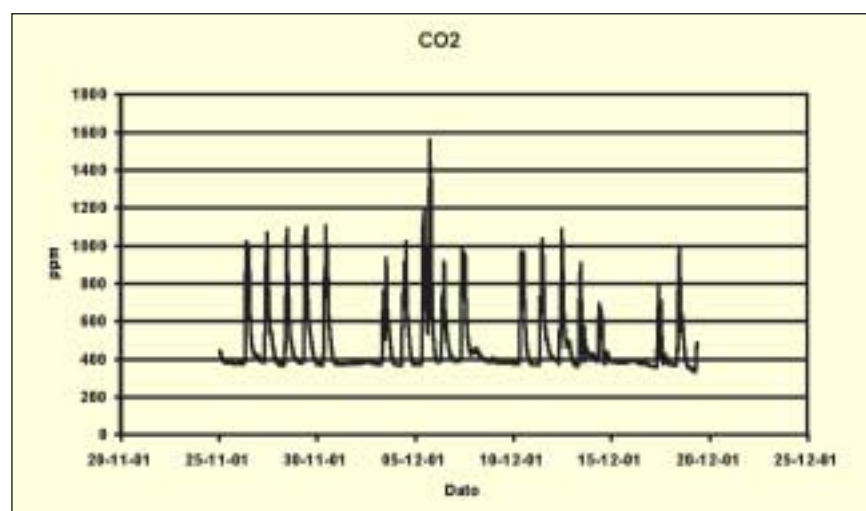
The indoor air quality has not been evaluated by questionnaires. Only the ventilation flow rate and the CO<sub>2</sub> level have been monitored. The CO<sub>2</sub> level has been monitored in one classroom during a cold winter period and the results are shown in the figure below. When the classroom is occupied the maximum CO<sub>2</sub> level is between 1000 and 1500 ppm. By tracer gas the air tightness was measured as 0.7 ach<sup>-1</sup> with closed dampers and 1.5 ach<sup>-1</sup> with dampers open.

**Figure 4:** CO<sub>2</sub> levels in a classroom during a winter period.
